# **Trip Report**

## **50th and Hayes Site**

## **Washington, District of Columbia**

**10 December 1999**

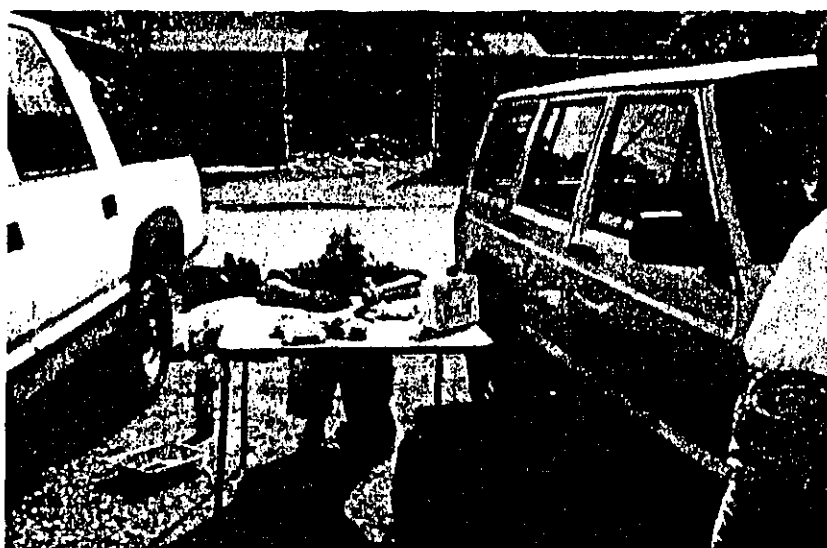
Five surface soil samples were collected for field hazcat testing. Samples SS-01, SS-03, and SS-04 did not exhibit ignitable or flammable characteristics. Samples SS-03 showed slight smoldering and a small brief flame was observed from sample SS-05.

Date Taken: October 1999  
Photographer: Region III SATA  
Description: SATA performing hazcat testing on surface soils for ignitability.
